**PREBID MEETING MINUTES  
STOCKLEY MAC CENTER ROOF REPLACEMENT  
26351 PATRIOTS WAY  
GEORGETOWN, DELAWARE  
DBF #0586B064.K01 ❖ OMB/DFM #MC3511000072  
JUNE 30, 2026**

***STOCKLEY MAC CENTER  
GEORGETOWN, DE***

***ROOF ASSESSMENT REPORT  
PO# 0000536441***

***January 27, 2021***

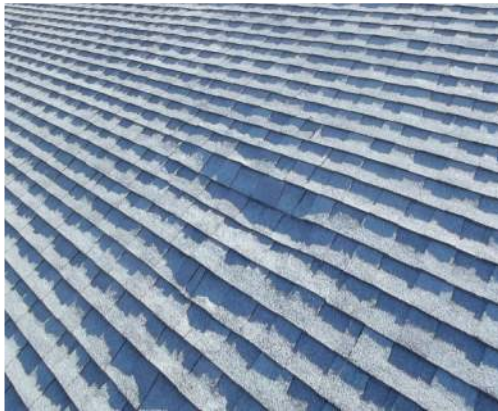
The plywood deck is generally in fair condition. There are localized areas where deterioration is suspected. Visible deflection in the roof deck across the building was documented. (See Photo 1 and Photo 2) The fireproofing on the underside of the deck is delaminating and falling to the floor of the attic space (See Photo 3 and Photo 4). Additionally, RRI suspects that the roof deck was insufficiently/improperly secured in multiple locations. Ridges noticed in the shingles appear to match the vertical seams of the plywood (ridges 8' O.C.). From the interior, in several areas that were accessible, there appeared to be fasteners missing or spaced several feet apart.

Photo 1 – Roof deck deflection in field of roof.

The sections of roof that have noticeable deflections should be repaired before water infiltration occurs. Sections of shingles, underlayment and plywood should be removed and replaced. The areas to be replaced will be determined by the amount of plywood that has to be removed in order for the seams of new plywood to align properly on the sub-structure. After the deck is repaired, a new underlayment and architectural shingles should be installed to blend into the existing roof.

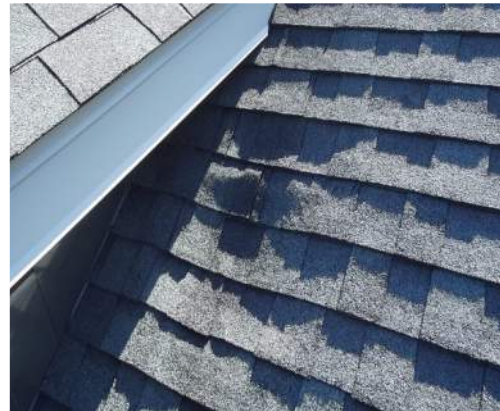
Photo 2 – Roof deflection below dormer valley.

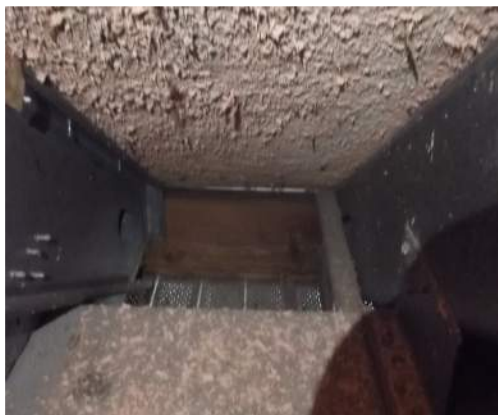
The delamination of the fireproofing on the underside of the plywood and the deflection in the deck may be caused by insufficient or inadequate ventilation of the space underneath the roof deck. Attic space ventilation and potential condensation issues should be further investigated by a Mechanical Engineering Firm.

Photo 3 – Fireproofing delaminating from plywood.

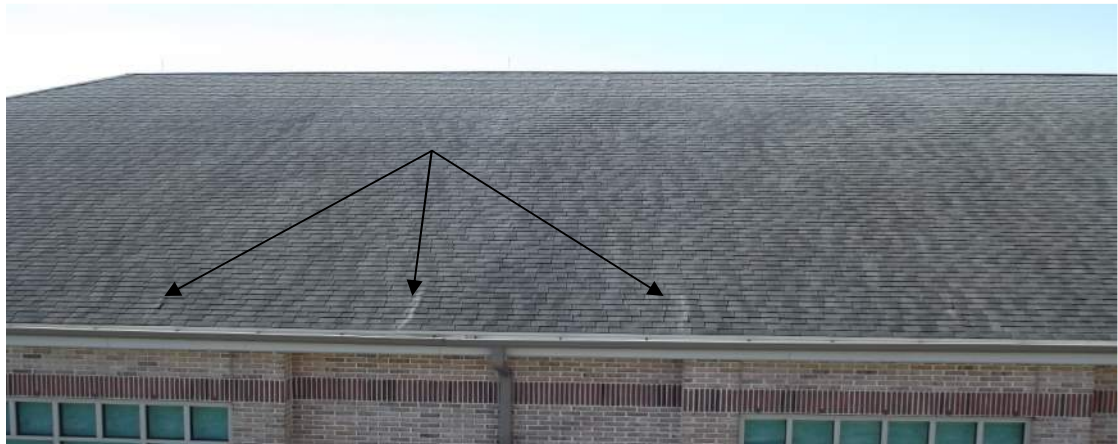
Questions arose surrounding the attachment of the roof deck because a consistent was pattern noticed in the shingles at the eaves of the roof (Photo 5) and conditions observed on the interior. Ridges spaced 8' O.C. were documented around the facility. The telegraphing of these seams could be caused by insufficient fasteners or because original installation lacked the use of plywood clips between the hat channels to prevent the plywood from cupping at the vertical seams. Given the age of the roof (approx. 14 years), these conditions could wait to be addressed during a future roof replacement that will have to address the fireproofing at the roof deck. RRI examined the plywood focusing explicitly on the attachment of the roof system. The interior areas observed by RRI did not appear to show deterioration of the plywood that would affect the withdraw strength of the fasteners used to attach the roofing. A Fire Protection Engineer should be consulted about the condition of the fireproofing material on the underside of the plywood.

Photo 5 – Ridges in shingles at plywood seams.

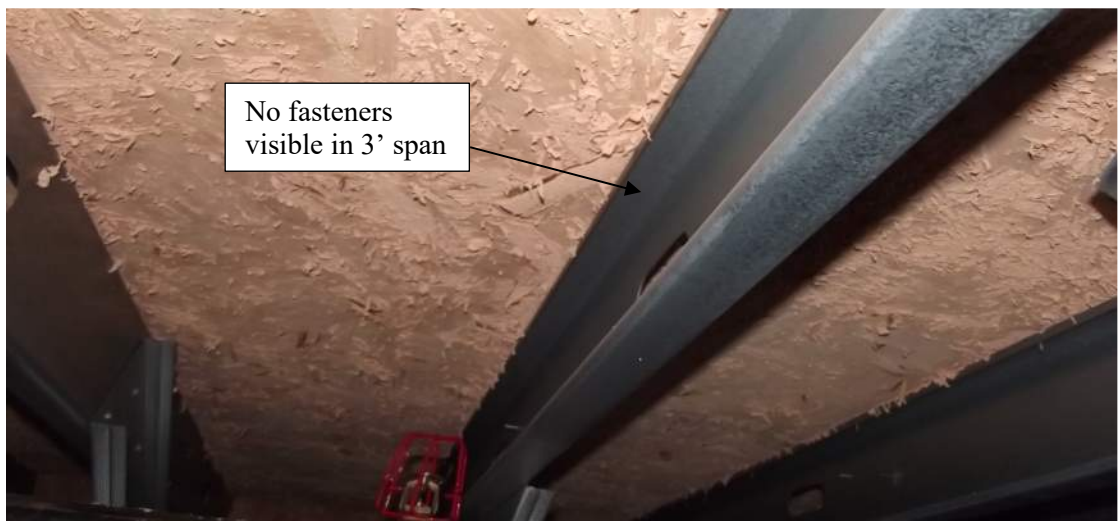
Photo 6 – Missing fasteners in plywood.

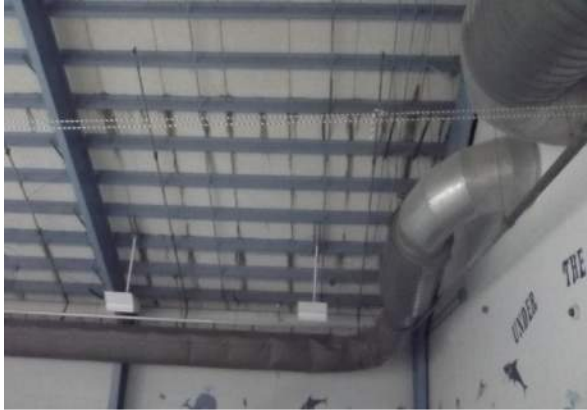
The roof deck assembly at the Therapy Pool Roof has interior and exterior issues visible. Widespread staining is present on the interior of the tectum deck. On the exterior portion of the roof deck there were several bulges that were noticed.

Photo 7 – Staining on tectum deck.

RRI was informed that the Therapy Pool is no longer in use. The interior staining appears to be the product of the humidity in the pool area and the ability of the air handling units to effectively remove that moist air. With the pool drained and the air handling system offline no action appears to be needed at this time.

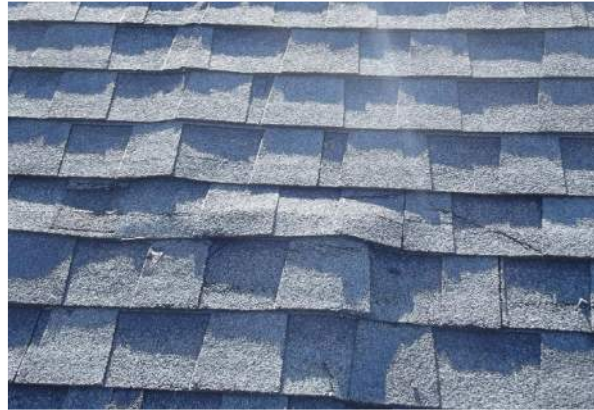
The bulges on the exterior portion of the roof deck may have also been caused by interior moisture conditions. The bulges in the roof deck do not appear to be affecting the integrity of the roof system or leading to water infiltration. Considering the age of the roof, no action is needed until the roof is slated to be replaced or a leak occurs.

Photo 8 – Bulge in roof deck.

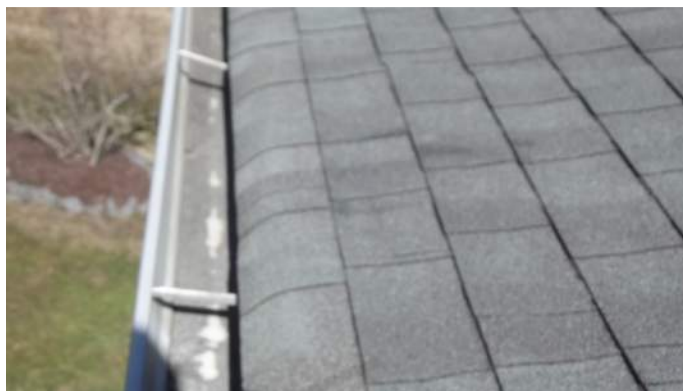
The shingles, which overall appear to be correctly installed have an excessive overhang at the eaves and rakes. Standard overhang for a shingle at the eave and rake drip edge is  $\frac{3}{4}$ " and can vary according to manufacturer. The reveal observed on site at the rake and eave was almost double that recommended by manufacturers. This condition over time will cause the shingles

Photo 11 - Shingles curling down into gutter.

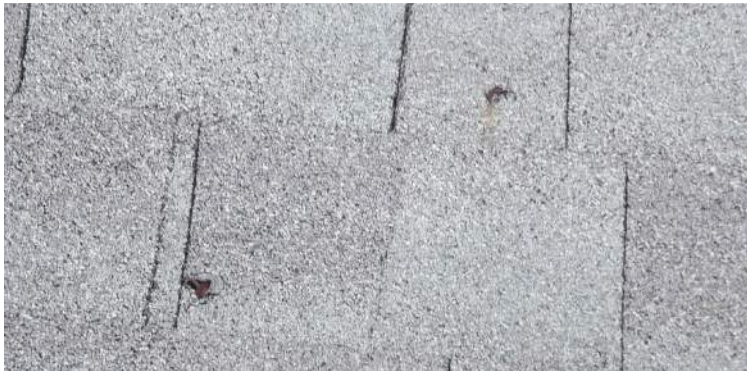
Photo 14 – Loose shingles at dormer.

The existing roof appears to be in good condition with normal weathering and with preventative maintenance appears to have a fair amount of useful life remaining. Preventative roof maintenance to address nail pops and missing or loose shingles should take place to prevent potential leaks.

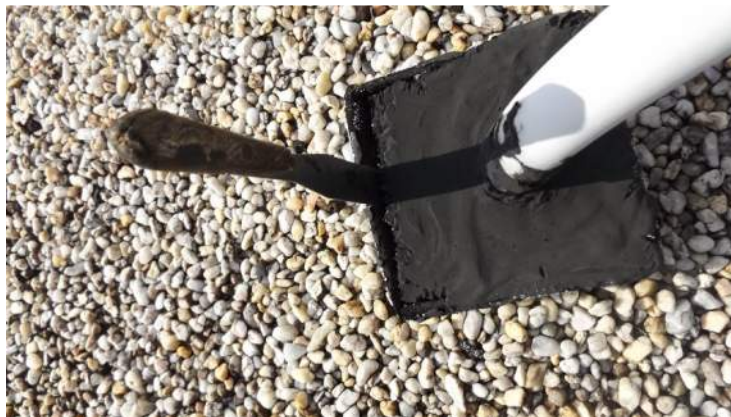
pockets have started to show signs of deterioration and there are rooftop items that have been incorrectly installed or abandoned.

Photo 15 – Deterioration at pitch pocket. Typical condition

Preventative maintenance on the low-slope systems will ensure that they reach the end of their warranted period/useful life without burdensome leak issues. The existing pitch pockets should be removed and re-installed or re-flashed with a fluid applied membrane with an embedded fabric reinforcement. There are also several rail curbs and penetrations that are no longer in use but were not properly abandoned. These items should be removed or properly flashed. Finally, items including the large speaker system and the fall protection railings around the roof hatches should be addressed. The speaker was not set on a slip/sacrificial sheet and will start dig into the roof membrane over time. The railings at the roof hatches are in poor shape and are no longer functioning properly. Replacement of the railings should be considered.

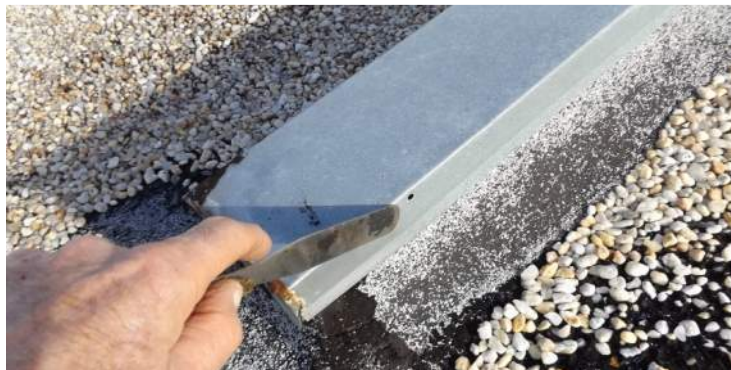
Photo 16 – Abandoned rail curb. Metal cap is not secured.

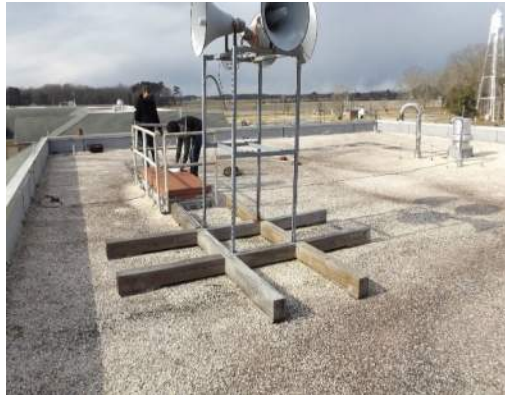
Photo 17 – Wood base of speaker system is not on a slip sheet.

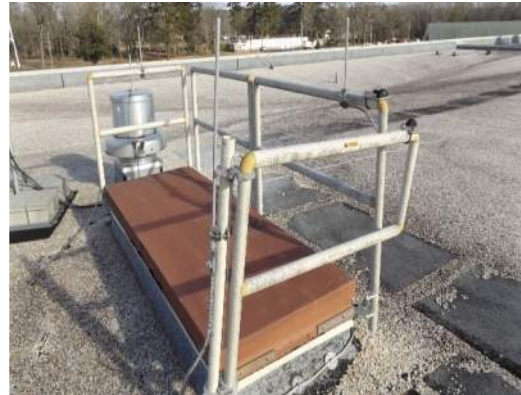
Photo 18 – The fall protection rails around the hatch units are deteriorating.

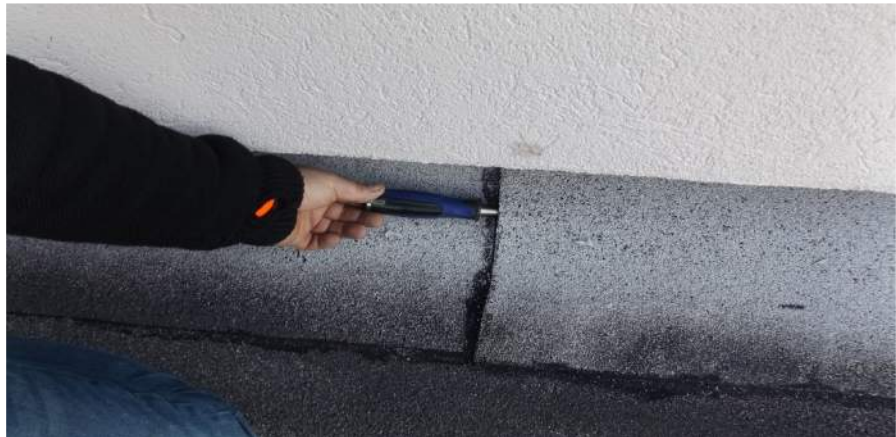
These roof areas appear to be in good condition. There are however components that should be addressed with regular maintenance before water infiltration occurs. The flashing that meets the rising wall of the Therapy Pool Building has openings at the seams. The Entrance roof appears to have had all its seams coated with roof mastic and fabric.

Photo 21 – Opening  
in flashing at rising  
wall.

The open flashing sections on the Therapy Pool Vestibule roof should be repaired using an asphalt roof mastic and reinforcement fabric.
