Project: ASD Summit Campus

Location: Middletown, Delaware

**RE: Geotechnical Engineering Services – Addendum 1  
Appoquinimink School District Summit Campus – Infiltration Testing Summary  
Middletown, Delaware**

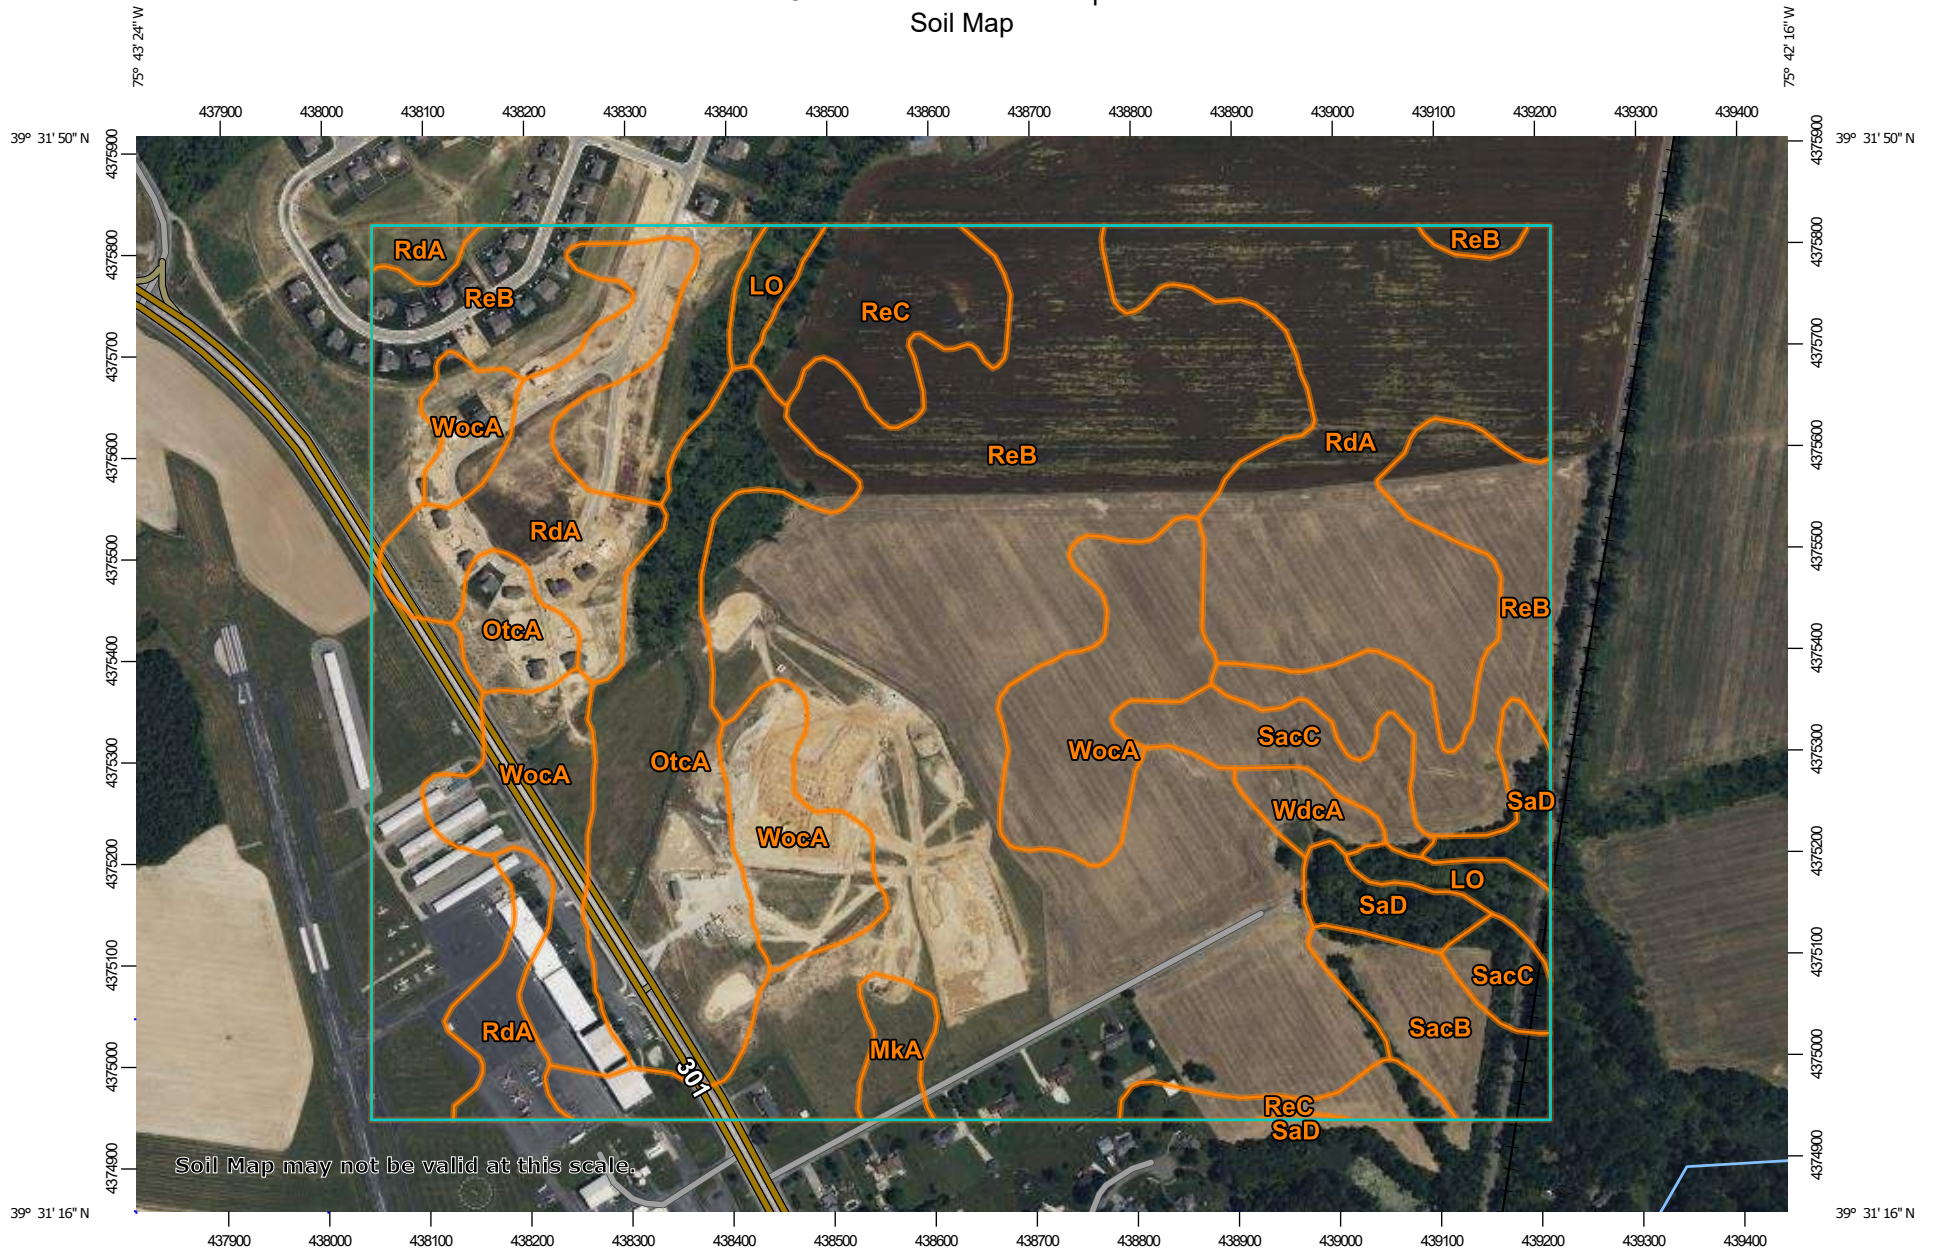
# Custom Soil Resource Report Soil Map

The soil map section includes the soil map for the defined area of interest, a list of soil map units on the map and extent of each map unit, and cartographic symbols displayed on the map. Also presented are various metadata about data used to produce the map, and a description of each soil map unit.
