**PREBID MEETING MINUTES  
STOCKLEY MAC CENTER ROOF REPLACEMENT  
26351 PATRIOTS WAY  
GEORGETOWN, DELAWARE  
DBF #0586B064.K01 ❖ OMB/DFM #MC3511000072  
JUNE 30, 2026**

***STOCKLEY MAC CENTER  
GEORGETOWN, DE***

***ROOF ASSESSMENT REPORT  
PO# 0000536441***

***January 27, 2021***

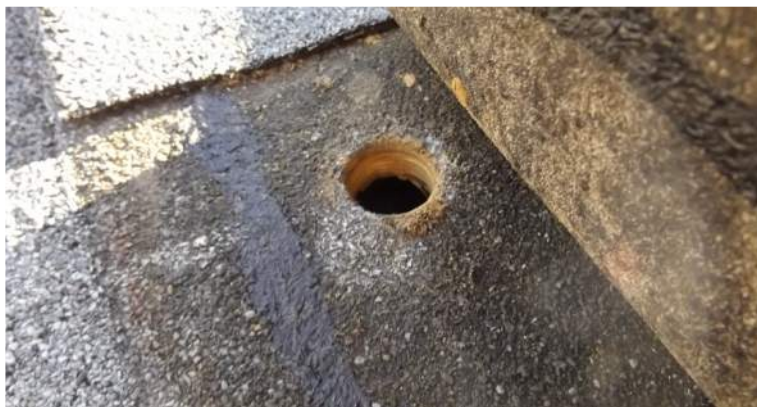
The Therapy Pool Roof (RA – 13) appears to have a multi-layer roof deck system. On the interior of the facility, tectum panels of an undetermined thickness are visible. A core taken from the exterior appears to show the tectum panels are topped with a OSB plywood. There is an air space of approx. 3/4” which we assume is caused by battens attached to the tectum panel, followed by a 5/8” CDX plywood deck to which the shingle roof is attached.

Photo 8 – Roof core taken at Therapy Pool.

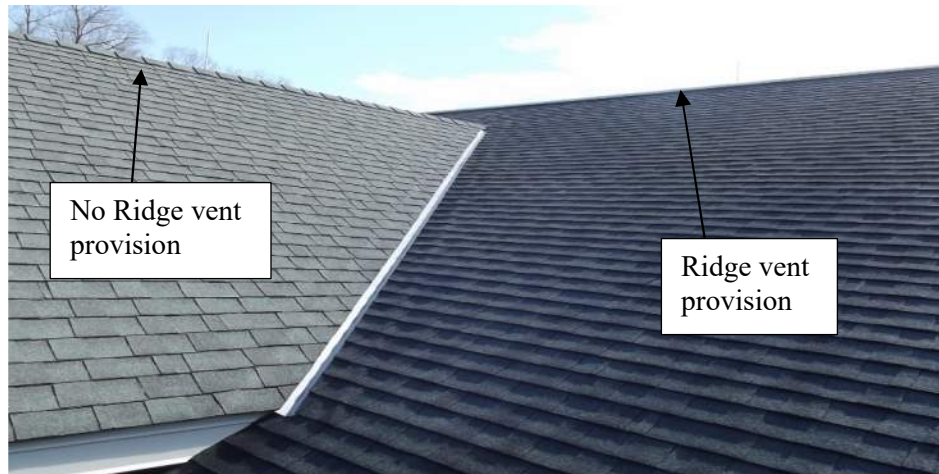
The shingled sections of roof make up the majority of the total square footage of roofing at the facility. The light gray mineral coated architectural shingles appear to be in good condition overall. Step flashings, counter flashings and valleys are constructed out of stainless steel and also appear to be in good condition. A shed style ridge vent is present at the transition between the shingle roof system and the modified built-up roof system on the low sloped section. The dormers across the building do not have a ridge vent installed.

Photo 9 – Overview of shingled roof

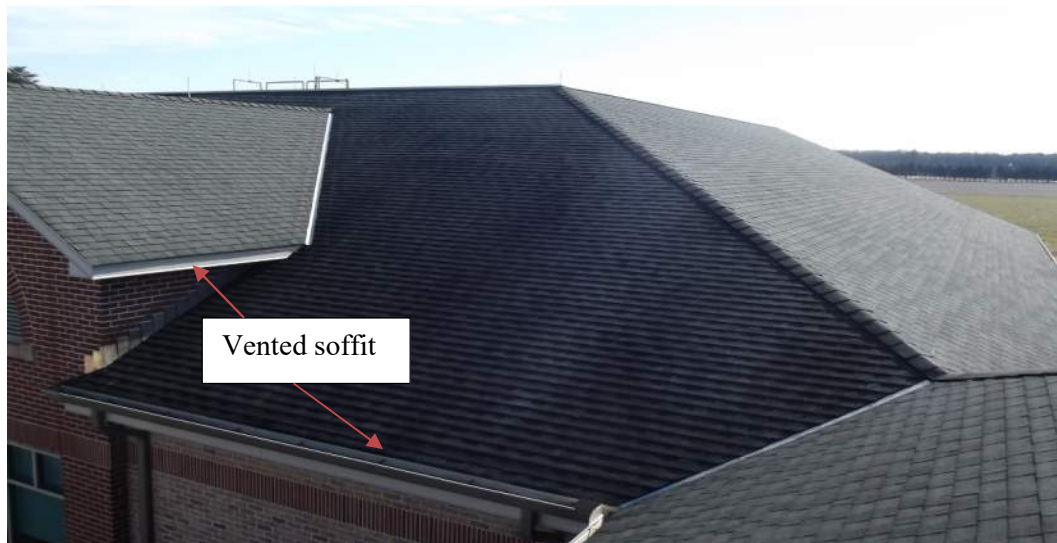
Photo 10 – Overview shingled roof

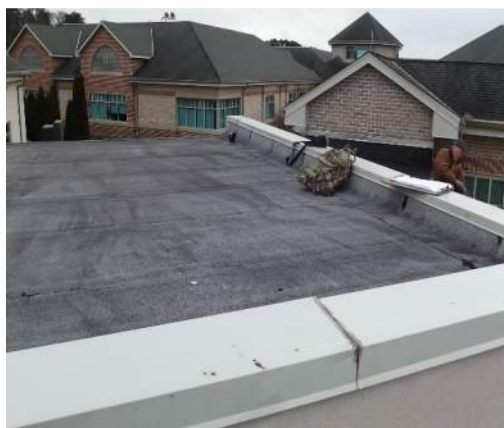
Photo 19 – Roof Overview

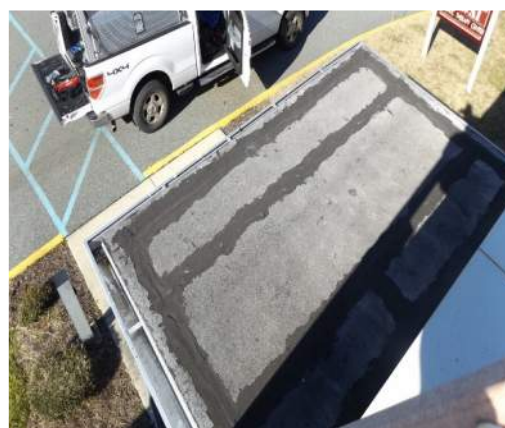
Photo 20 – Entrance Roof

Photo 21 – Opening  
in flashing at rising  
wall.

The open flashing sections on the Therapy Pool Vestibule roof should be repaired using an asphalt roof mastic and reinforcement fabric.

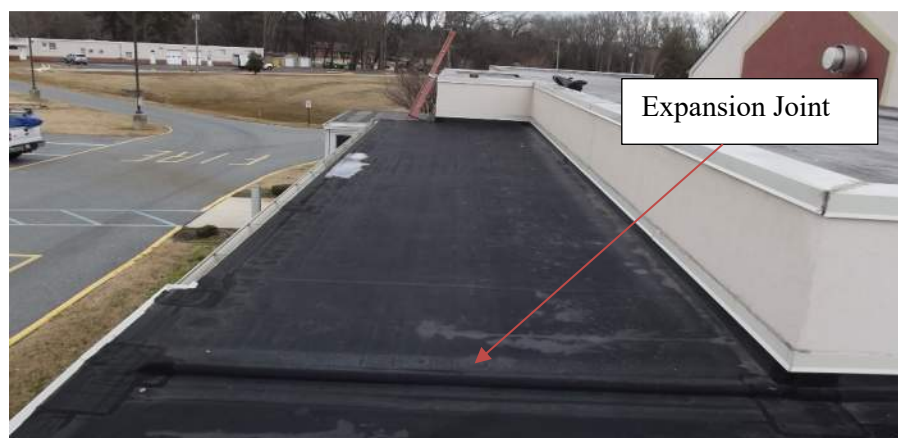
Photo 22 – Therapy Pool Corridor Roof Overview

There is currently no recommendation for this area.

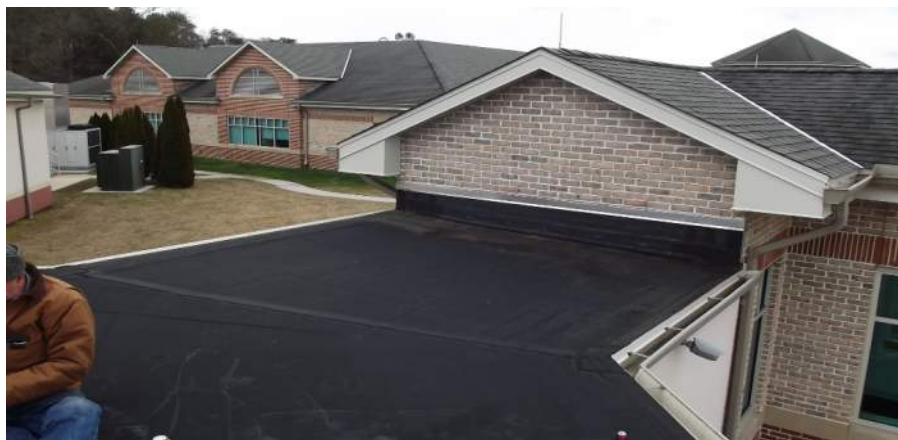
Photo 23 – Therapy Pool Corridor Roof Overview

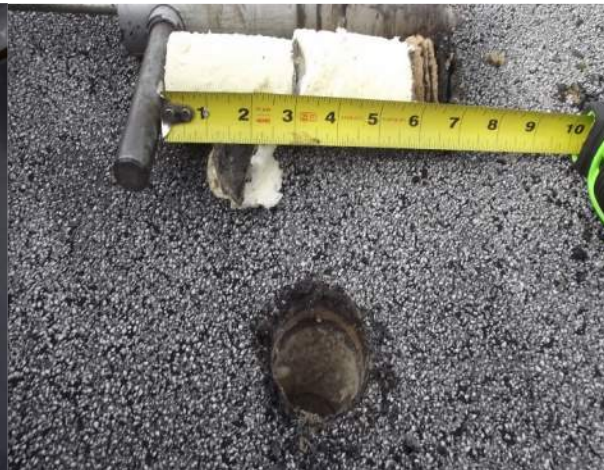
Roof Core Pool Vestibule Roof RA - 14

| Roof Area/Core # | System Construction | Wet (Y/N) | Asbestos |
|---|---|---|---|
| Core #8<br>Therapy<br>Pool<br>Vestibule<br>RA- 14 | Metal Deck, 6.5" Polyisocyanurate, .5" Fiber Board, .5" Two-ply modified roof set in hot asphalt. Taper in structure. | N | N/A |
